Fuel Depletion, Restriction and Management

Keywords: *Transportation
- Safety - Aeronautical -
Occurrence Investigation -
Safety Bulletin - Fuel*

Abstract

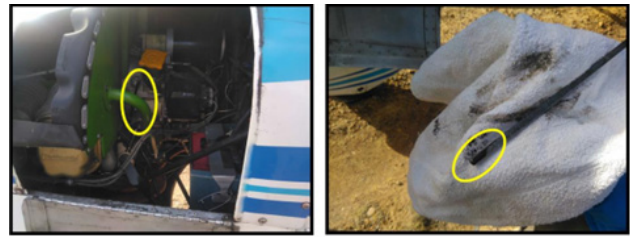
Figure 1. Oil quantity check using the dipstick

- The oil quantity in the engine was 6 liters less than the minimum required for operation, which caused fluctuations and a decrease in oil pressure during the power reduction.
- The spark plugs were in a state of advanced deterioration.
- The air filter used was not suitable for aviation use, and its condition may have resulted in higher than expected fuel consumption.

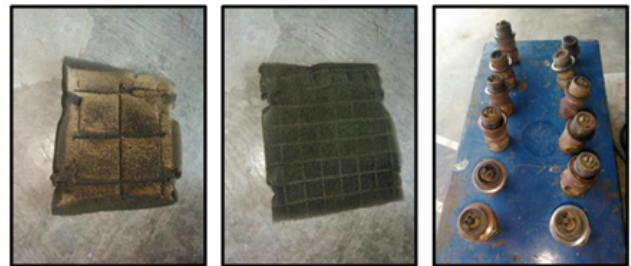
Figure 2. Engine air filter and spark plugs

The combination of these conditions likely resulted in increased fuel consumption, which reduced flight endurance.

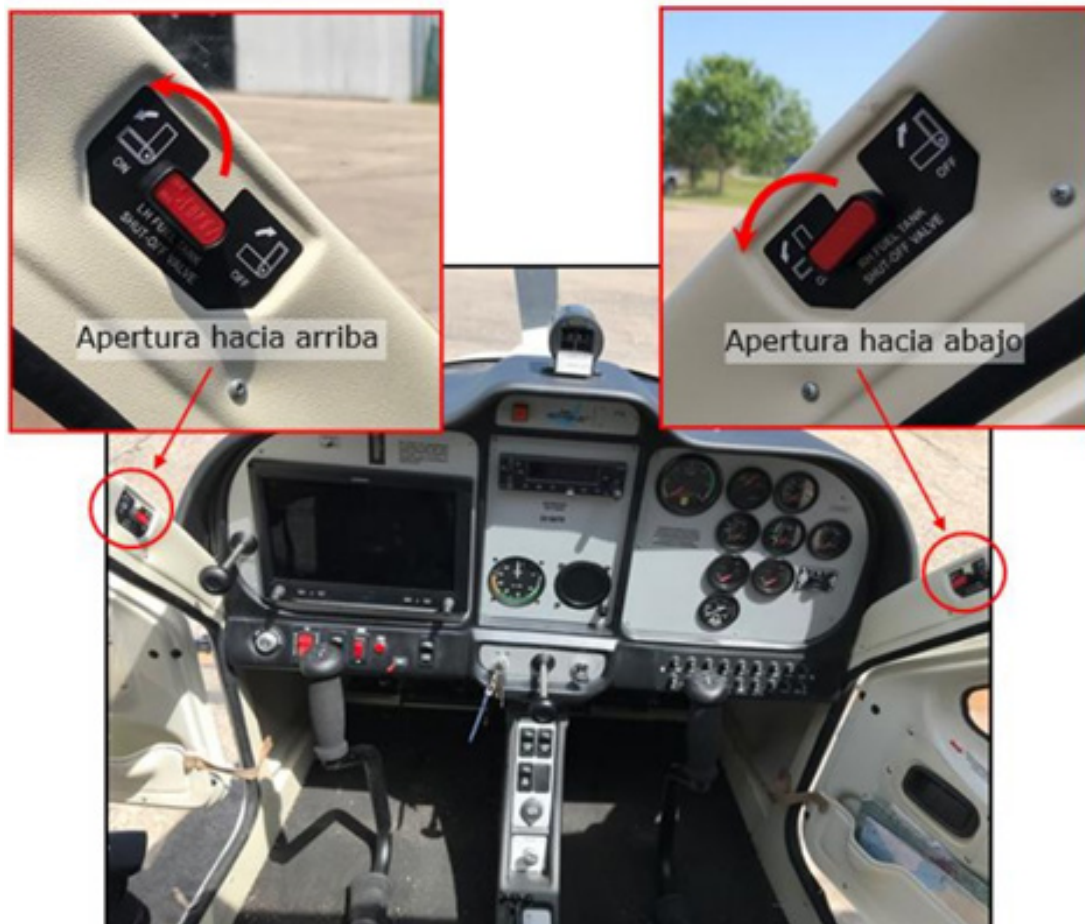
Figure 3. Fuel selector valves of an aircraft similar to the one involved in the accident

The investigation found that the left fuel tank had approximately half a liter, while the right tank contained about 30 liters of fuel. The opposing logic of the fuel tank opening valves may have induced undesirable behavior,

which likely set the stage for the engine stoppage. These findings suggest that the fuel selector valve for the right tank was closed at the time of the engine stoppage.
