Level Crossing Occurrences in Argentina and Proactive Actions

Studies area of the JST
National Directorate of Railway
Investigations.

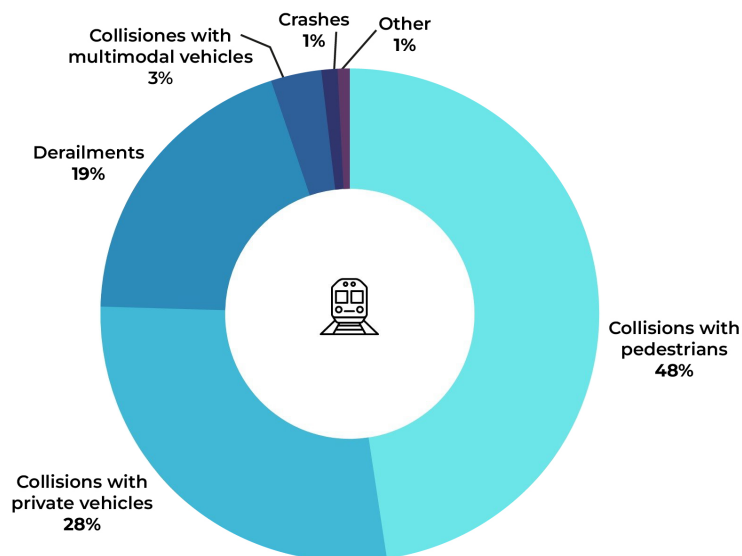
Chart 1. Total railway occurrences recorded in 2022²

In 2022, 750 railway occurrences were recorded, of which 47% were train collisions with pedestrians, and 28%, collisions with private vehicles.

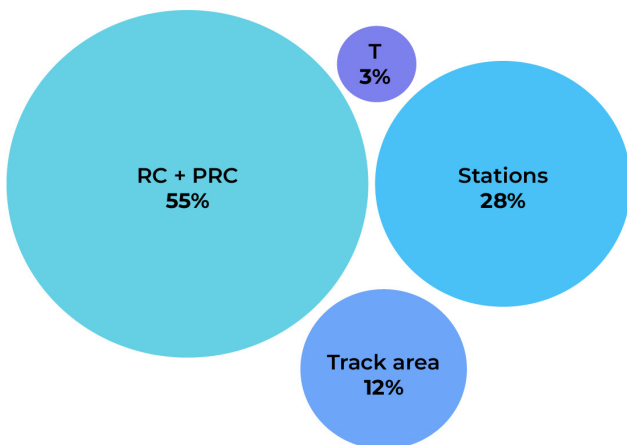
Chart 2. Occurrences by type of location

If occurrences are analyzed by type of location, 55% occurred at level crossings (Table 2 and Chart 2). Regarding occurrences at LCs, collisions with vehicles (private and commercial) and collisions with pedestrians can be differentiated (Table 3 and Chart 3).

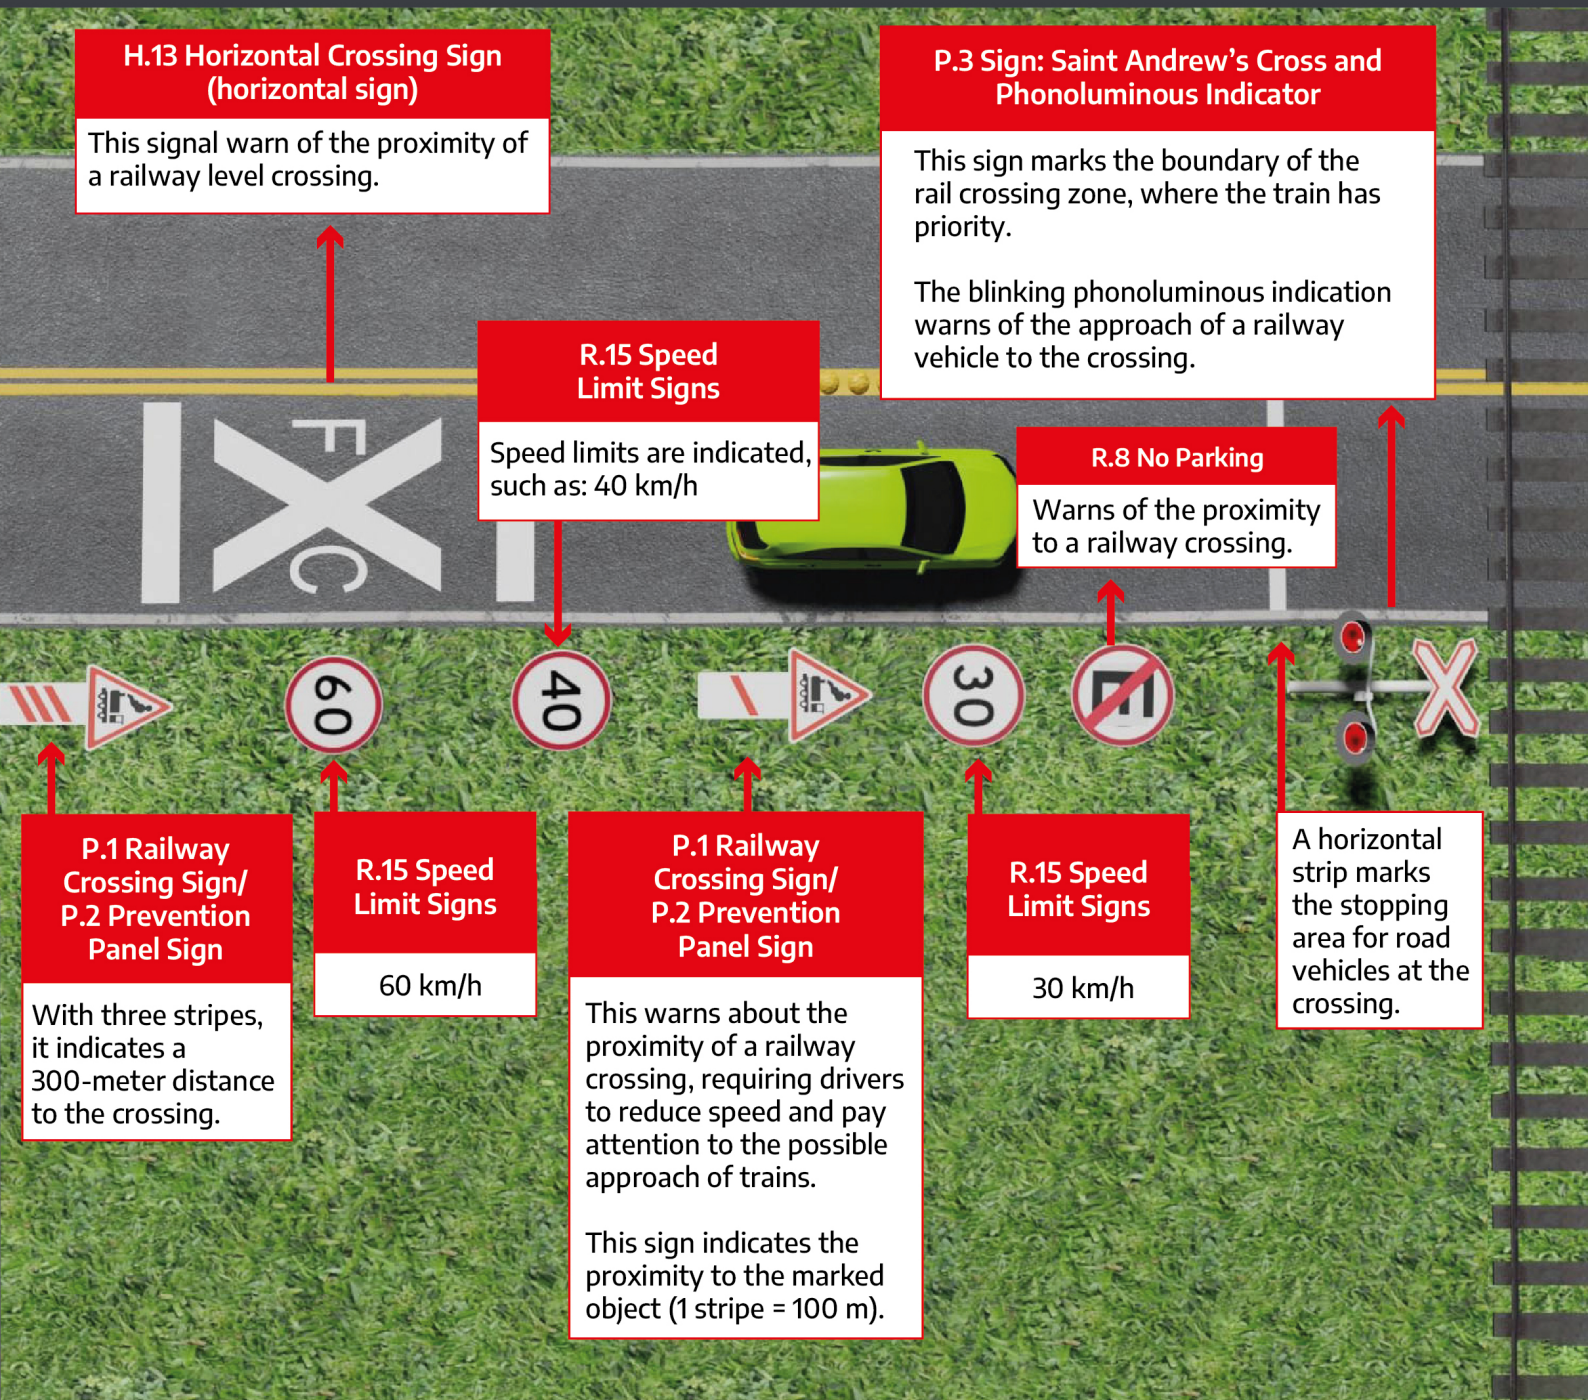
RURAL LEVEL CROSSING WITHOUT BARRIER

H.13 Horizontal Crossing Sign (horizontal sign)

This signal warn of the proximity of a railway level crossing.

P.3 Sign: Saint Andrew's Cross and Phonoluminous Indicator

This sign marks the boundary of the rail crossing zone, where the train has priority.

The blinking phonoluminous indication warns of the approach of a railway vehicle to the crossing.

R.15 Speed Limit Signs

R.8 No Parking

Warns of the proximity to a railway crossing.

P.1 Railway Crossing Sign/ P.2 Prevention Panel Sign

With three stripes, it indicates a 300-meter distance to the crossing.

This warns about the proximity of a railway crossing, requiring drivers to reduce speed and pay attention to the possible approach of trains.

This sign indicates the proximity to the marked object (1 stripe = 100 m).

A horizontal strip marks the stopping area for road vehicles at the crossing.

In Argentina, the signage varies depending on the type of LC, which can be urban or rural, with or without a barrier. These are regulated by SETOP Resolution No. 7/81.
